**TELEDYNE CONTINENTAL® AIRCRAFT ENGINE**  
**MANDATORY SERVICE BULLETIN**

**Category 1**  
**MSB09-1A**  
**Technical Portions FAA**  
**Approved**

**SUBJECT: CYLINDER REPLACEMENT**

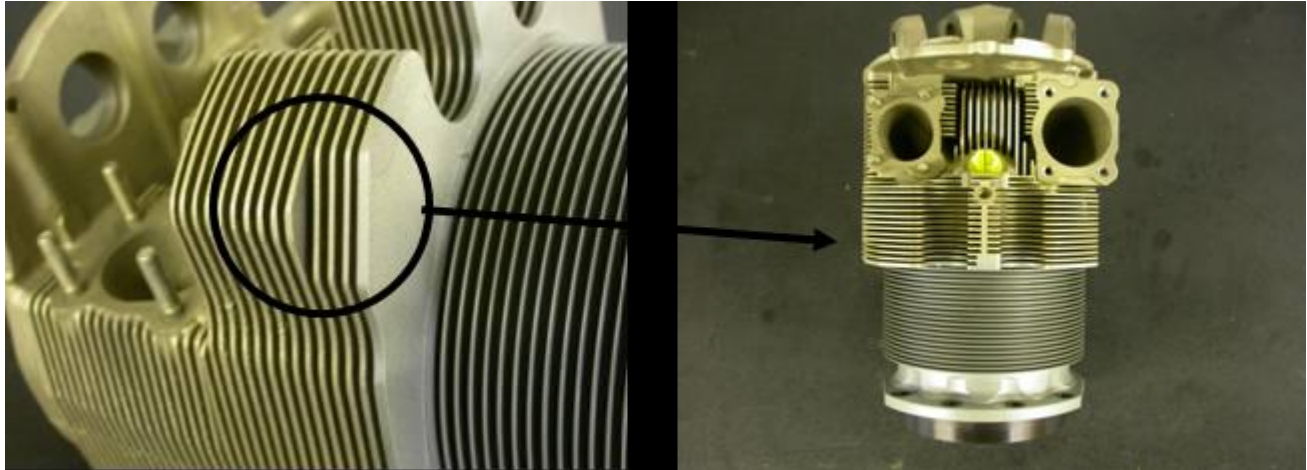
**FIGURE 1**  
**Cylinder Head Casting Four (4) Fin relief Location**

The EQ3 head casting cylinder assemblies are identified by a four (4) fin relief at the bottom lower left hand portion of the cylinder head (as installed on the engine) and a depression cast EQ3 in the cylinder head rocker boss (overhead) area as shown in Figures 1 and 2. These cylinders are to be replaced in accordance with the guidelines set forth in this bulletin and based upon applicable engine model and aircraft manufacturer procedures. All EQ3 cylinders must be replaced no later than December 31, 2009.

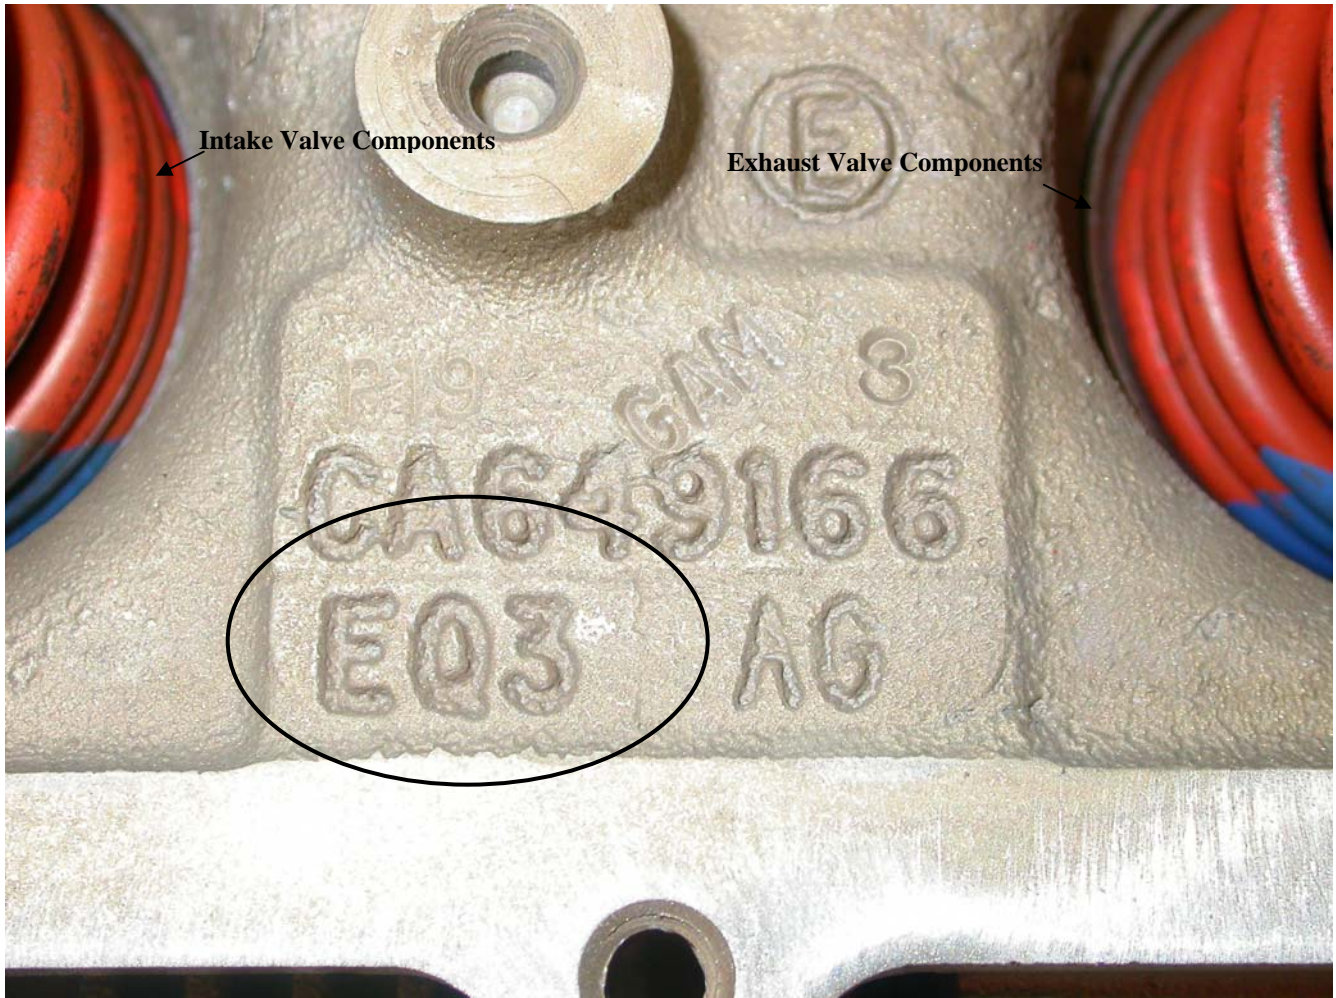
**FIGURE 2 Location of EQ3 Marking in the Cylinder Head Rocker Box Overhead Area**

1. Cylinders with a depression cast EQ3 in the cylinder head rocker boss area as shown in Figure 2 are covered by this MSB and must be exchanged.
2. Contact TCM in accordance with the completion and registration section below.

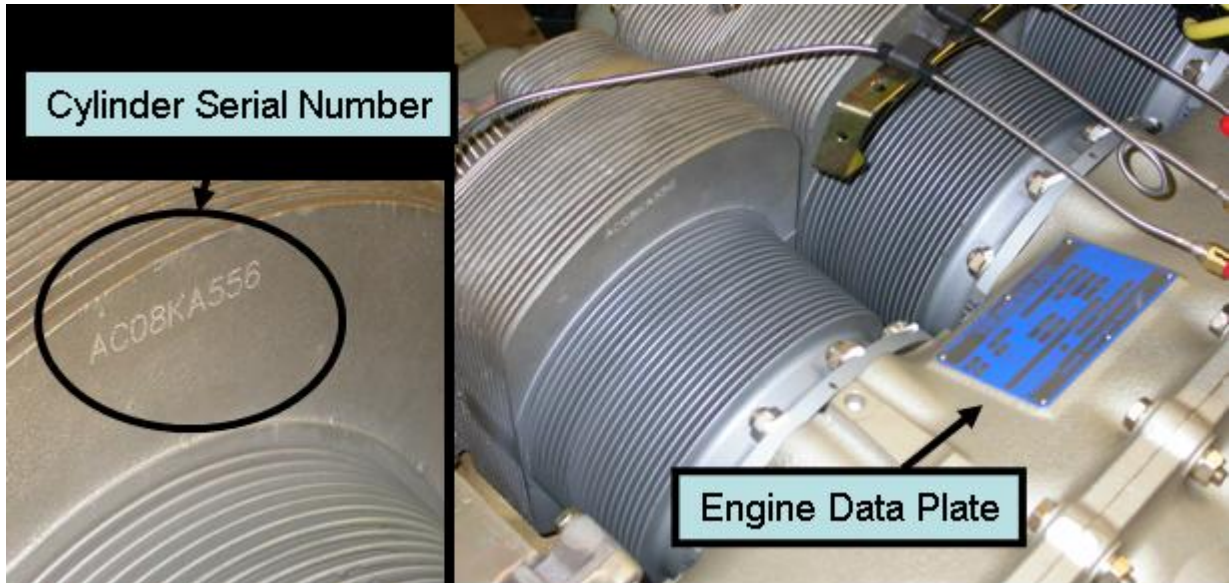
**FIGURE 3**

Inspect all potentially affected cylinders, within the next twenty (20) flight hours, but no later than April 30, 2009. Verify affectivity of all engine models and cylinders in accordance with Tables 1, 1A, 2, and 2A and the MODELS AFFECTED section. The engine serial number is located on the engine data plate and the cylinder serial number is located on the crankcase side of the top portion of the cylinder head as installed on the engine (Reference Figure 3).

- c. If a number casting mark **is not** present, then the cylinder may be covered by this MSB. Verify the EQ3 cylinder S/N as shown in Figure 3 is present and listed in Table 2. If so, proceed to completion and registration and **STEP 2**.

**Cylinder Serial Number and Engine Data Plate Locations**

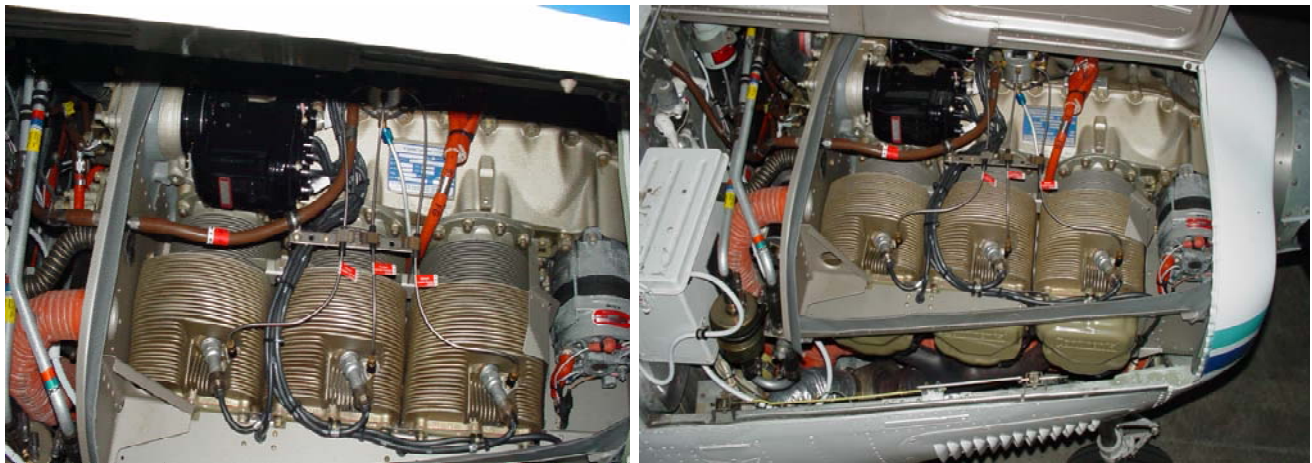
**FIGURE 4**

1. Open or remove the engine cowling in accordance with the airframe manufacturer’s instructions to the point necessary to allow visual access to the cylinders on both sides of the engine (Figure 4).

**Example of Top Down View with Cowling Removed  
Typical Engine Installation**
